Telfer, John Raymond (1979) Failure modes of an alumina-based machining ceramic. Masters thesis, Middlesex Polytechnic. [Thesis]

FAILURE MODES OF AN ALUMINA-BASED MACHINING CERAMIC

Failure Modes of an Alumina-Based Machining Ceramic

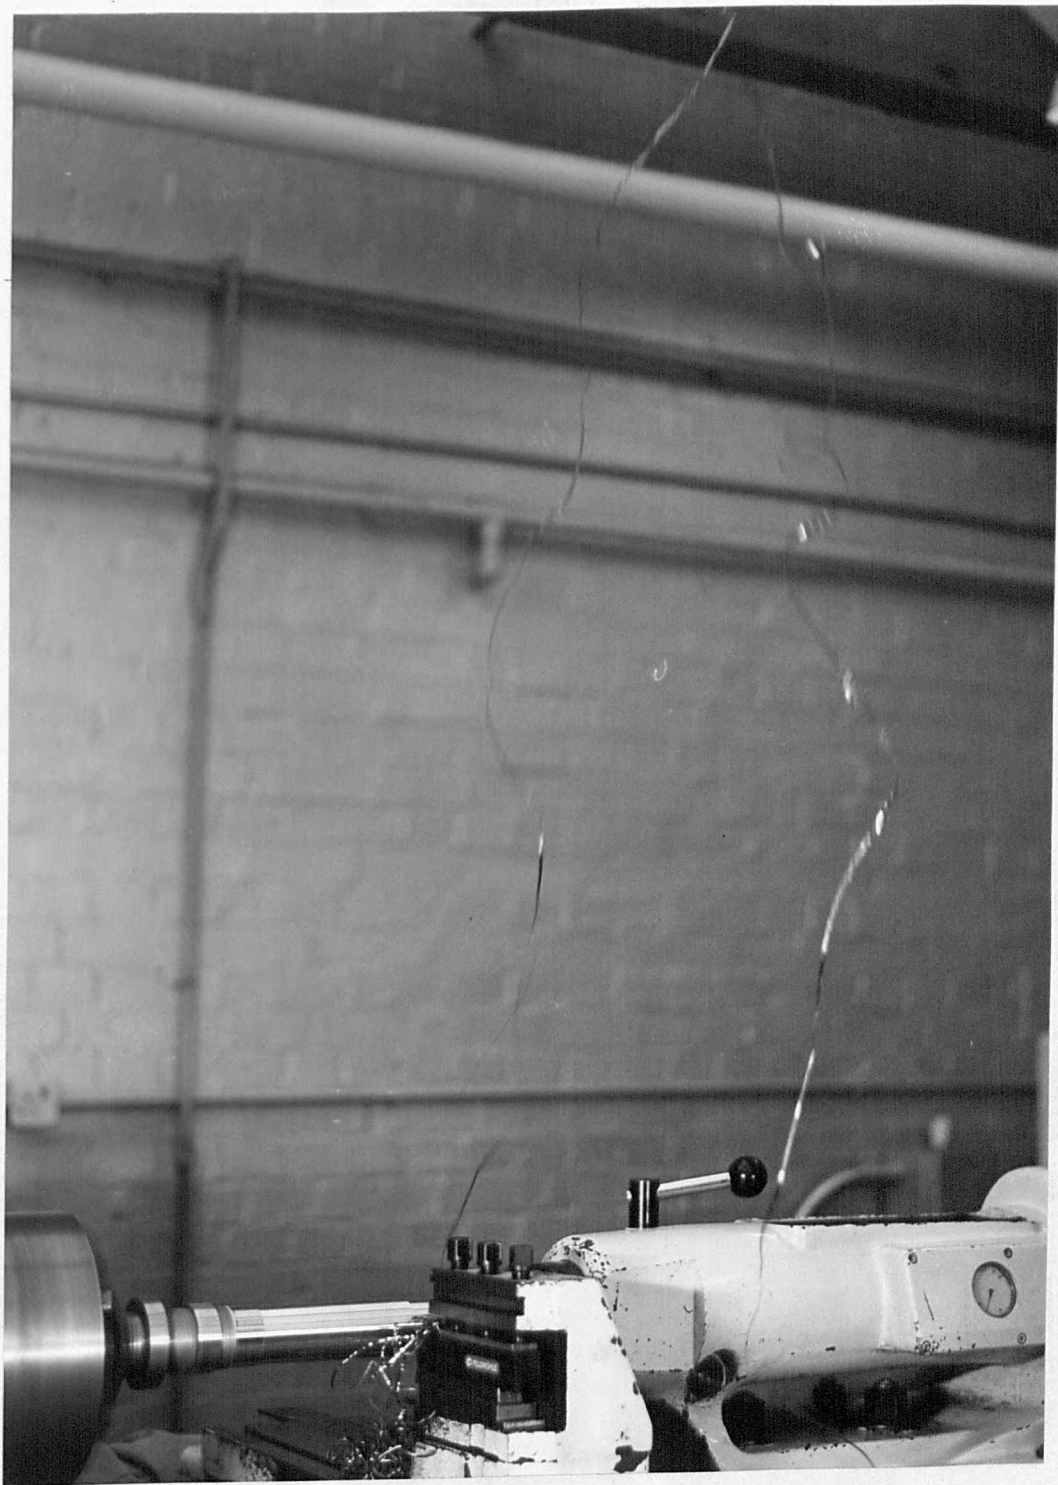
Fig.3.3.8. Swarf behaviour at cutting speed of 4500 ft/min with depth of cut 0.05 in and feed rate of 0.005 in/rev.

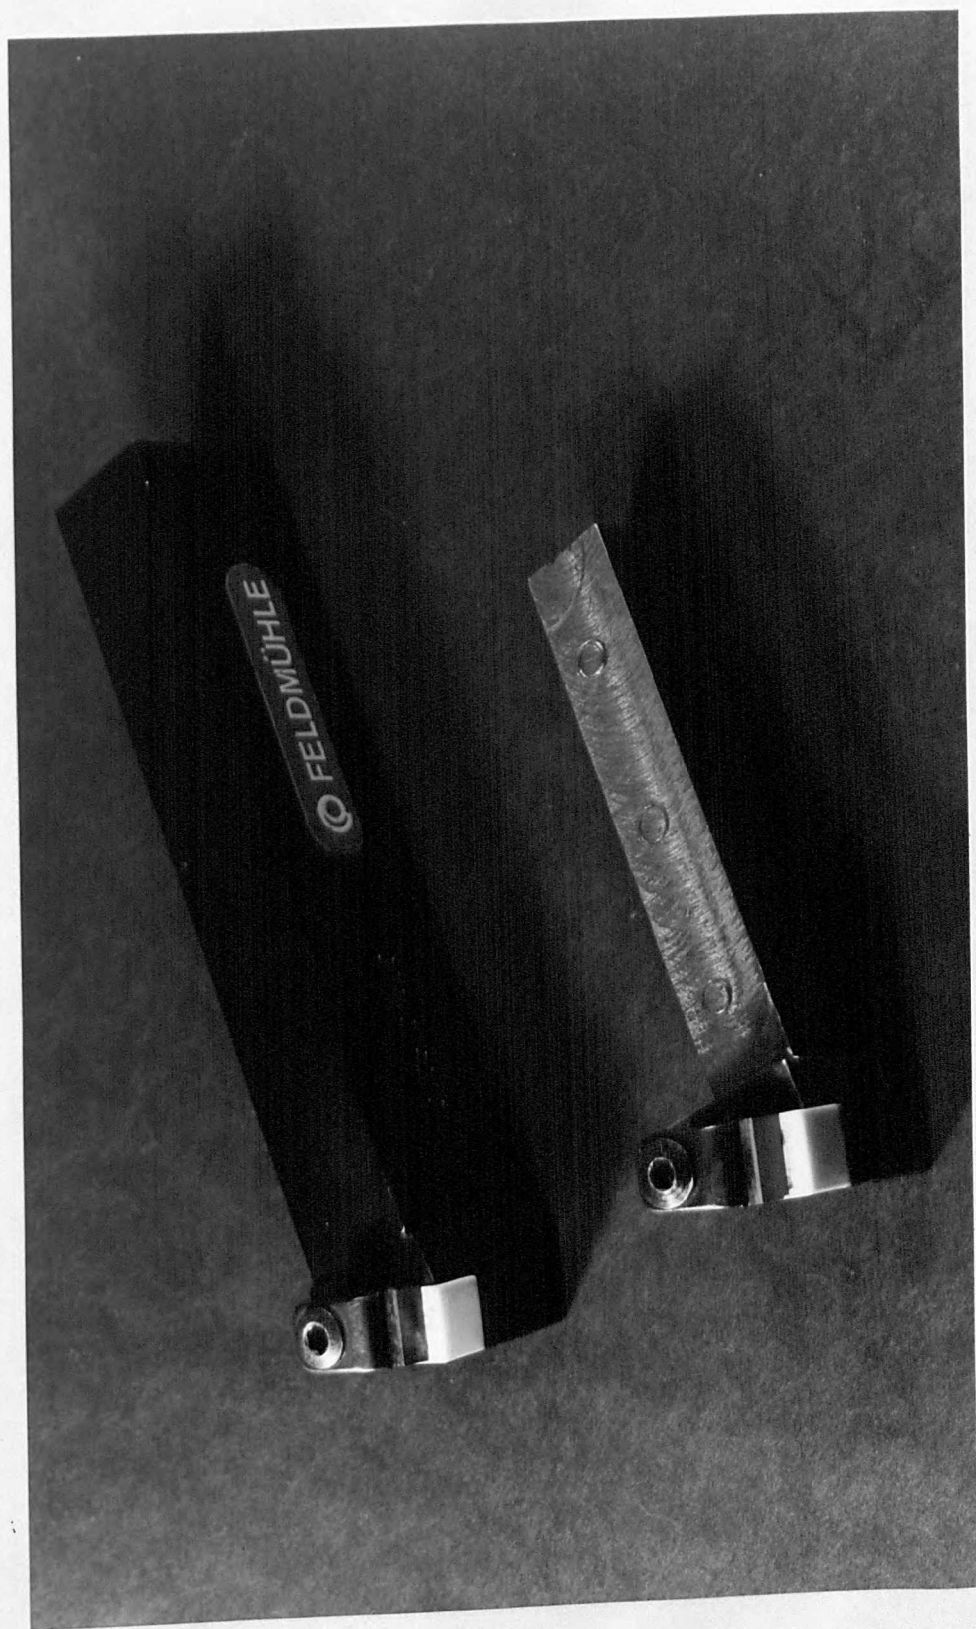
Fig. 3.4.1. Duplicate tool holder reduced on shank to suit Mecalex dynamometer.

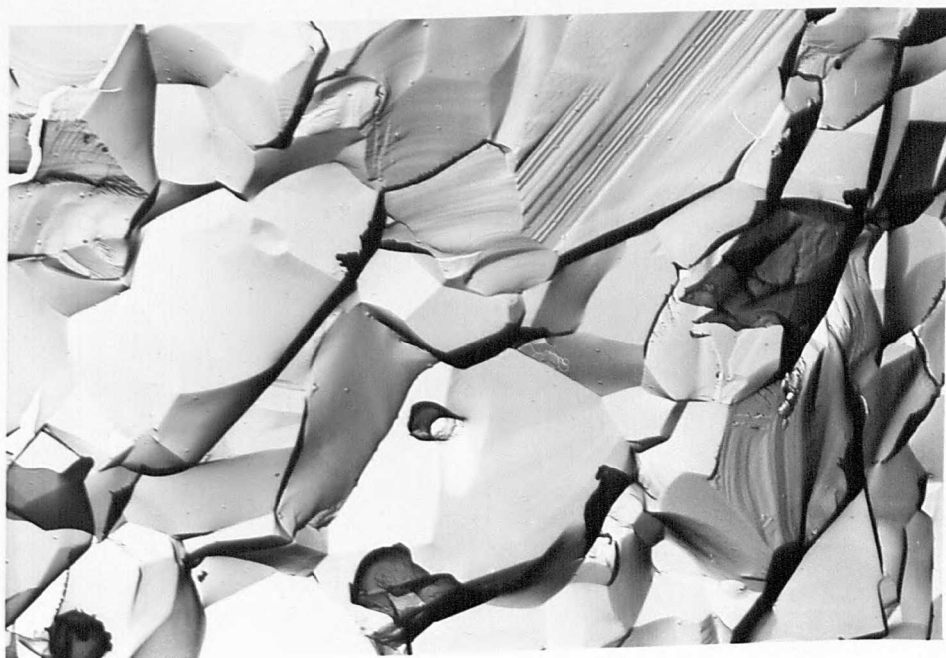
Fig.3.11.1. Micrographs of tool tip fracture surfaces. 8000X.  
 (a) Intergranular and transgranular fracture. (b) Porosity.

Fig.3.11.1. (c) Fracture surface.4000X.  
(d) Transgranular fracture.16000X.

Fig.3.11.1. (e) Isolated alumina sphere inside crystallite.13000X. (f) Fracture surface.10000X.

Fig.3.11.1. (g) Line of pores.20000X.  
 (h) Fracture surface.2500X.

Examination by electron microscopy of the broken tool tips revealed a predominance of intergranular fracture and two distinct modes of transgranular cleavage, one of which was influenced by pore concentrations in geometric patterns.

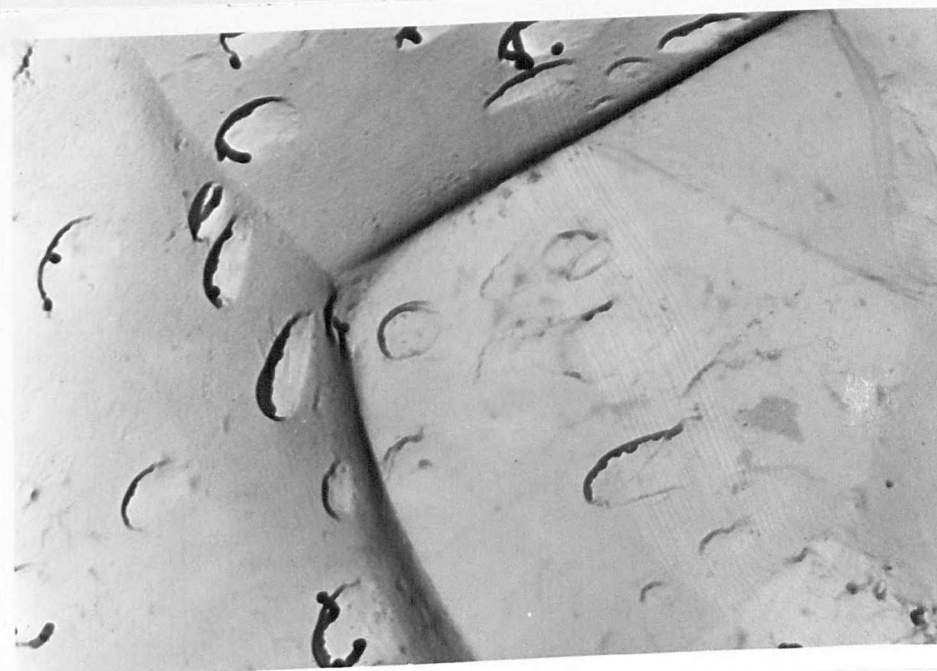
Fig.4.4(a) and (b). Showing random distribution of type 3 pore.  
 (a) in transgranular fracture surface.13000X.  
 (b) at grain boundaries. 10000X.
